#### 4.31 SWMU #31 - Container Storage Outside Process Areas (Photo 31)

5.0 AREAS OF CONCERN

## 6.0 RELEASE PATHWAYS

## 7.0 CONCLUSIONS AND RECOMMENDATIONS

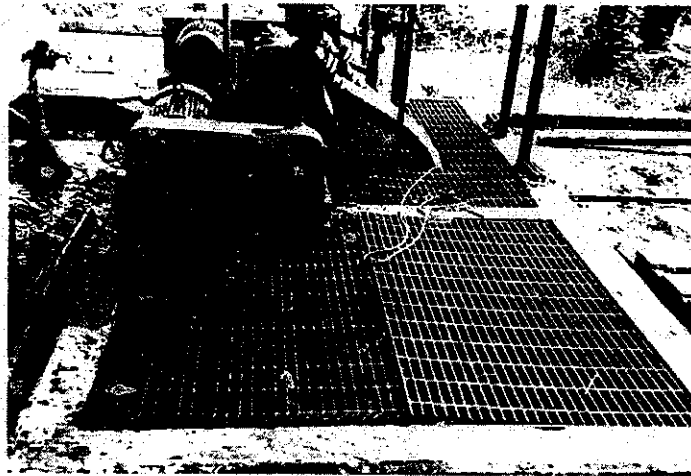
3. Magna/Chardonol/CC&P Facility, 9/20/91, 1:40 to 3:00. View to the south. View of the Wastewater Collection Sump (SWMU #3). Rain water has collected adjacent to the unit. The sump is composed of two cells which are separated by a four inch concrete wall. This unit was used to separate oily wastewaters. Oils were removed using a rope and belt skimmer. Oils removed from the wastewater were then stored in the adjacent Skimmed Oil Storage Tank (SWMU #4).

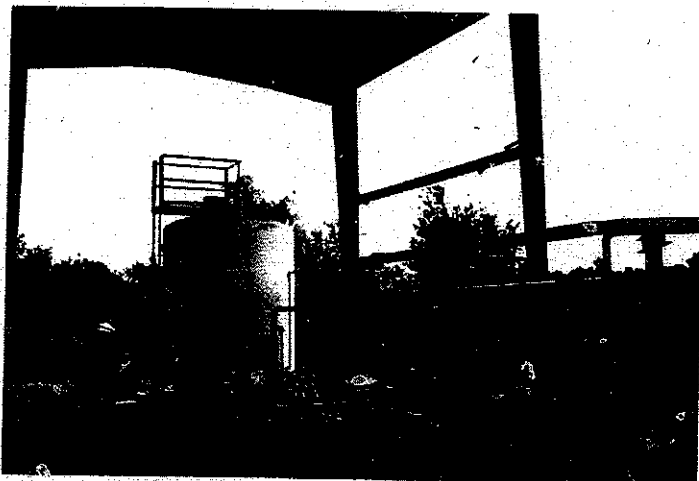
4. Magna/Chardonol/CC&P Facility, 8/29/91, 7:00 to 2:00. View to the northeast. View of the currently inactive Skimmed Oil Storage Tank (SWMU #4). This unit along with Wastewater Collection Sump (SWMU #3), was used to store waste oils collected from process wastewaters.

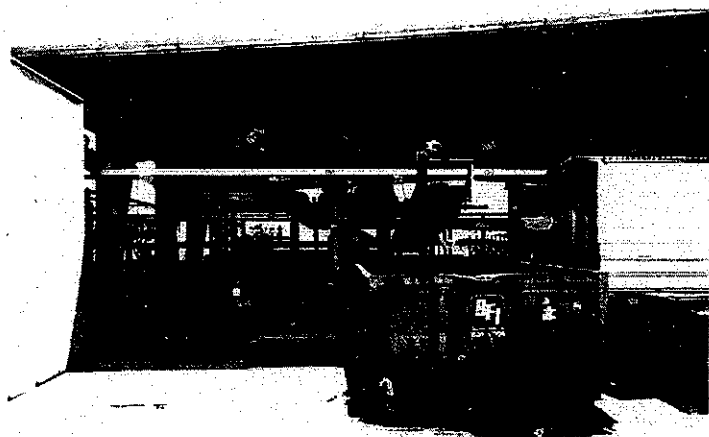
5. Magna/Chardonol/CC&P Facility, 9/20/91, 1:40 to 3:00. View to the south. View of Old Drum Storage Area at WWTF (SWMU #5). This area is now occupied by the WTP Sludge Hopper (SWMU #23).

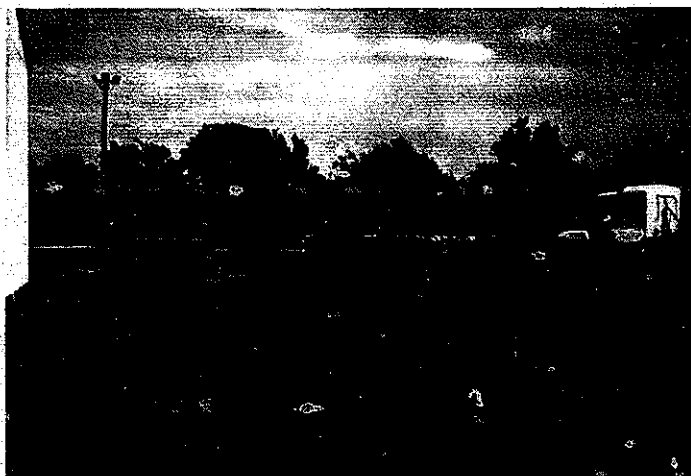
6. Magna/Chardonol/CC&P Facility, 9/20/91, 1:40 to 3:00. View to the east. View of Dumpster for Filter Press Cake (SWMU #6). The liquid seen in this photo is not associated with the unit.

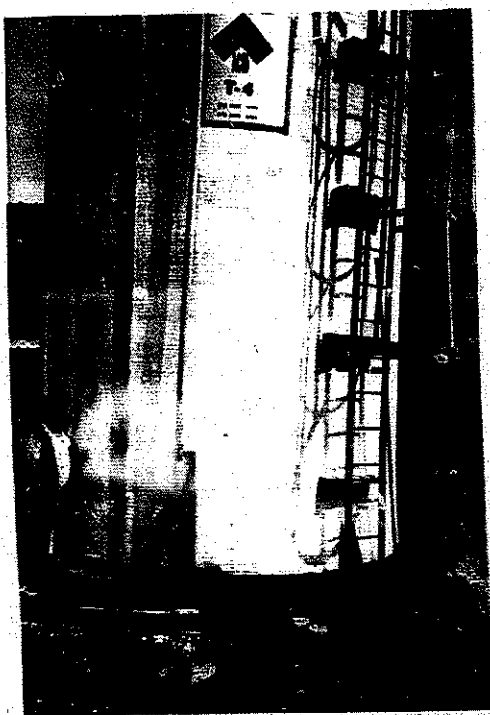
7. Magna/Chardonol/CC&P Facility, 9/20/91, 1:40 to 3:00. View to the east. View of Wastewater Holding Tank (SWMU #7). This 6000-gallon tank, which was constructed in 1981 to hold chemical materials used in the adjacent Treatment Pits (SWMU #8), is now used to store non-hazardous wastewaters prior to introduction into the Treatment Pits (SWMU #8). This tank was active at the time of the VSI.

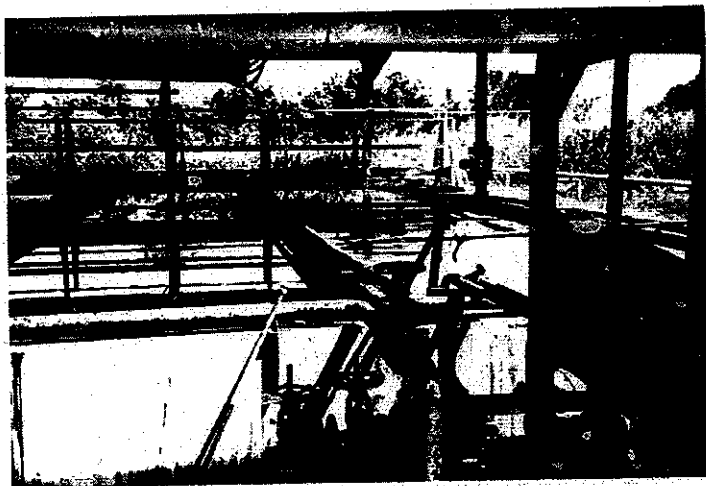
8. Magna/Chardonol/CC&P Facility, 9/20/91, 1:40 to 3:00. View to the east. View of the Treatment Pits (SWMU #8). This SWMU consists of seven rectangular concrete pits situated beneath an open sided structure. Catwalk (with yellow handrails) runs perpendicular to the length of the pits. Wastewater in these pits is subject to a flocculation process which represents the final stage in the on-site wastewater treatment prior to discharge to a POTW.

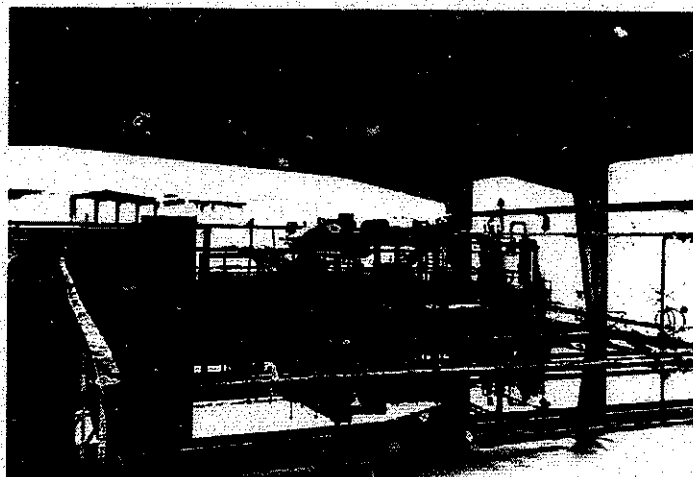
8.1 Magna/Chardonol/CC&P Facility, 9/20/91, 1:40 to 3:00. View to the north. View of the Treatment Pits (SWMU #8) from the catwalk. Note the Sludge Dewatering Belt Press (SWMU #9) in background.

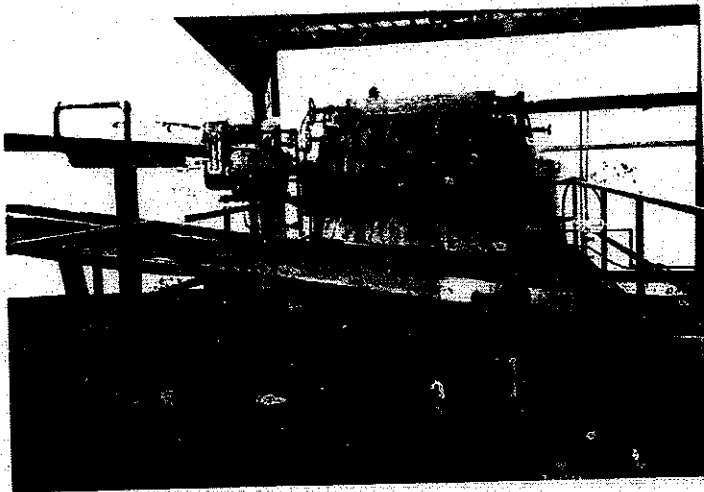
9. Magna/Chardonol/CC&P Facility, 9/20/91, 1:40 to 3:00. View to the east. View of the Sludge Dewatering Belt Press (SWMU #9). This unit mechanically dewateres sludges resulting from the flocculation process conducted at the Treatment Pits (SWMU #8).

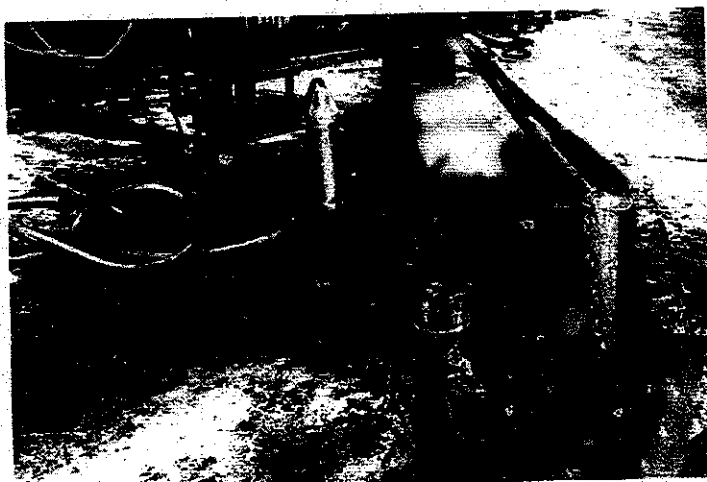
10. Magna/Chardonol/CC&P Facility, 9/20/91, 1:40 to 3:00. View to the northwest. View of a typical exterior example of the WWTF Piping/Chemical Sewer Conduits (SWMU #10). This extensive system of conduits collects process wastes from production and storage units located throughout the facility.

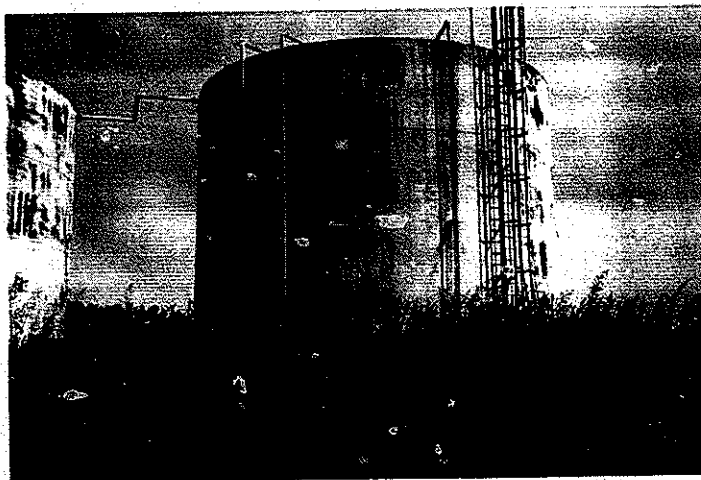
12. Magna/Chardonol/CC&P Facility, 9/20/91, 1:40 to 3:00. View to the east. View of the WWTF Enclosed Tank #2 (SWMU #12). WWTF Enclosed Tank #1 (SWMU #11) is located to the left. This 250,000-gallon tank stores process wastewaters from the facility prior to treatment in the on-site wastewater treatment facility. Only one tank is in use at any given time; the second tank is kept in reserve as an emergency backup unit.

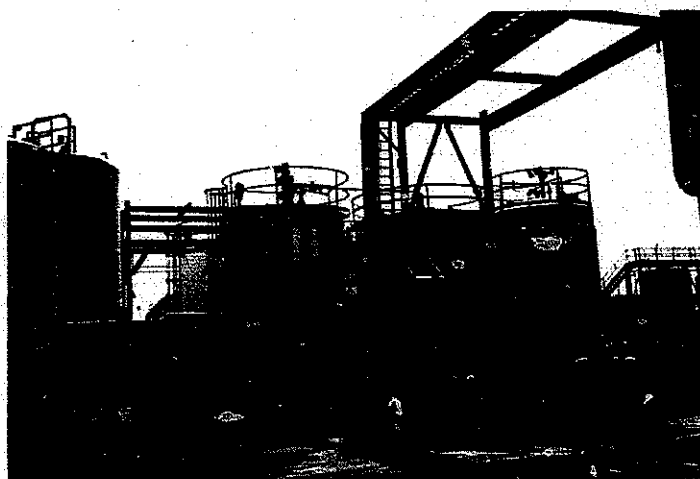
13. Magna/Chardonol/CC&P Facility, 8/29/91, 7:00 to 2:00. View to the east. View of the T-1011 Waste Storage Tank (SWMU #13). This 8,700-gallon tank is used to store process wastewaters. The tank is situated on a concrete pad and surrounded by a four foot concrete revetment wall. The other tanks in the photograph are product tanks. Photograph taken from the acrylic acid polymerization unit.

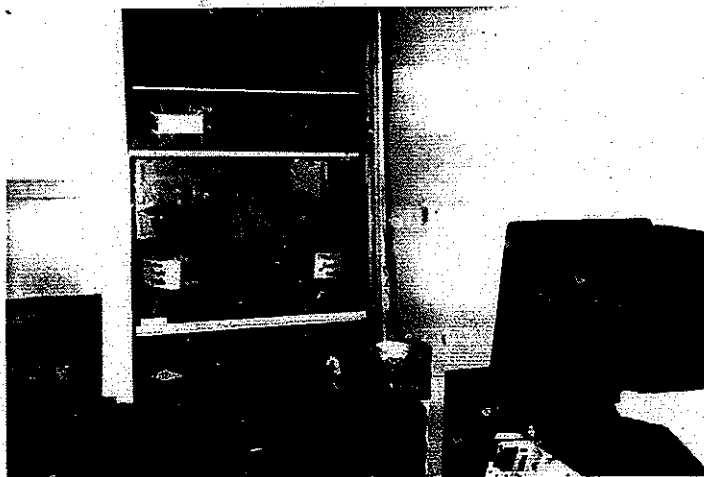
14. Magna/Chardonol/CC&P Facility, 9/20/91, 1:40 to 3:00. View to the south. View of the Waste Storage Area in Laboratory (SWMU #14). Wastes are stored in several locations at the laboratory. This is an example of management practices used in the facility's QA/QC laboratory.

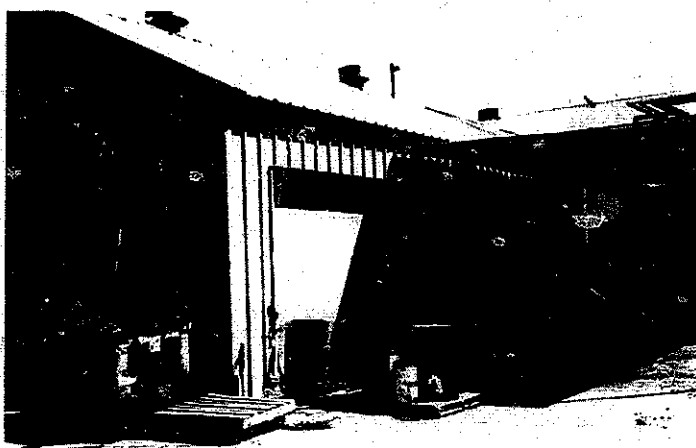
16. Magna/Chardonol/CC&P Facility, 8/29/91, 7:00 to 2:00. View to the northeast. View of the Container Storage Outside Maintenance Shop (SWMU #16). Used oils and cleaning chemicals are stored outside the shop on a concrete surface. This unit receives waste from Waste Storage Area in Maintenance Shop (SWMU #15). Puddles resulting from recent rains are evident in the background of the photograph.

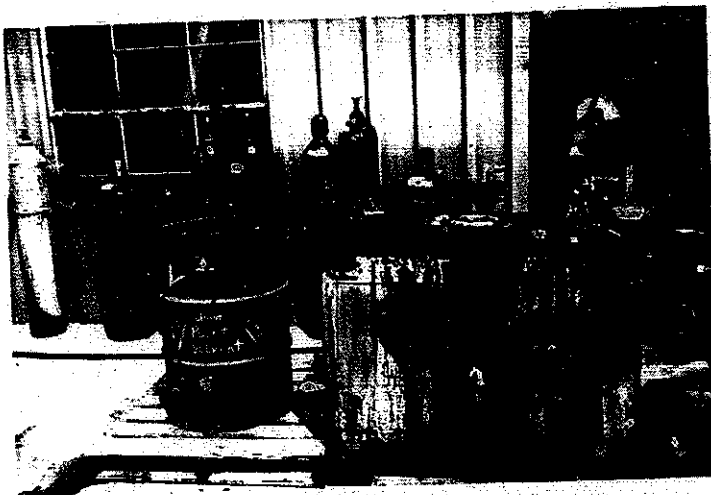
16.1 Magna/Chardonol/CC&P Facility, 9/20/91, 1:40 to 3:00. View to the east. View of the Container Storage Outside Maintenance Shop (SWMU #16). This photograph provides a detailed view of waste oil and solvent waste management containers.

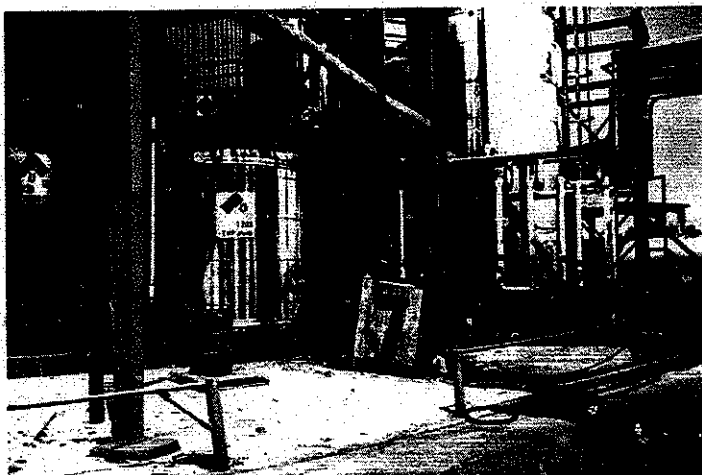
17. Magna/Chardonol/CC&P Facility, 9/20/91, 1:40 to 3:00. View to the east. View of the Tote Bins at Autoclave Units (SWMU #17).

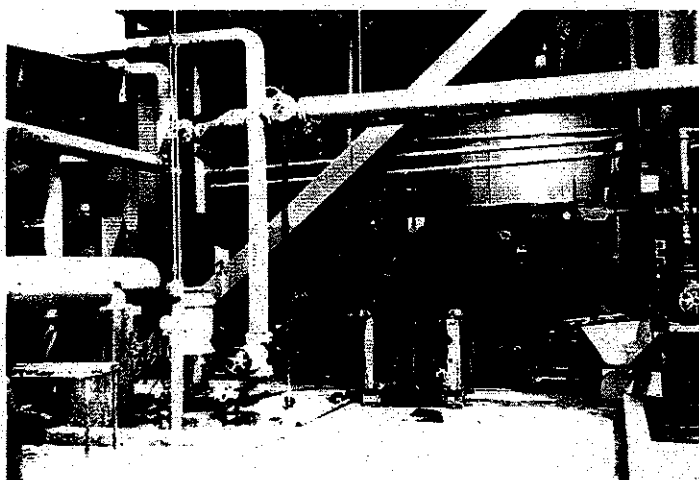
18. Magna/Chardonol/CC&P Facility, 9/20/91, 1:40 to 3:00. View to the east. View of the Tote Bins at Ester Kettle Unit 18 (SWMU #18). This is an example of one of the units used to collect process wastes resulting from the esterification and sulfonation of unsaturated polyester resins.

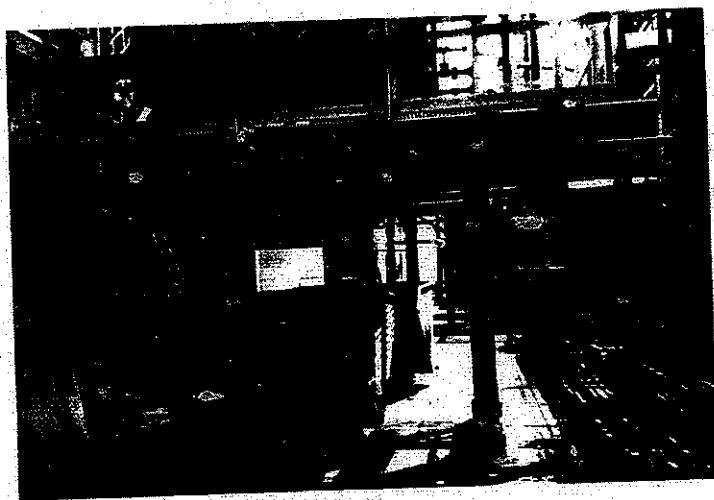
20. Magna/Chardonol/CC&P Facility, 9/20/91, 1:40 to 3:00. View to the south. View of the Dumpsters at Glass Lined Unit (SWMU #20). These dumpsters receive non-hazardous process wastes from the Glass Lined Unit.

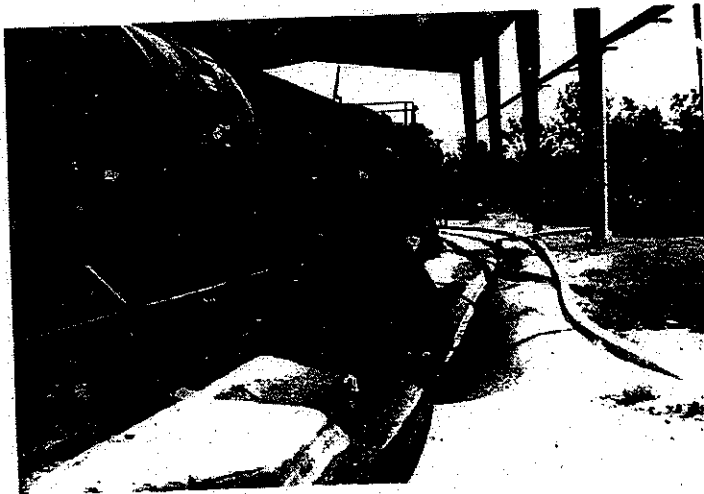
22. Magna/Chardonol/CC&P Facility, 8/29/91, 7:00 to 2:00. View to the north. View of the Metal Catch Trays at Tank Car Railside (SWMU #22). The metal catch trays are visible beneath the rail cars and are intended to collect drippings and spillage from car valves and couplings. These trays in turn empty into the concrete catchment system seen in the center right portion of this photograph. Note that both the trays and concrete catchment systems appear to contain liquids and are noticeably discolored.

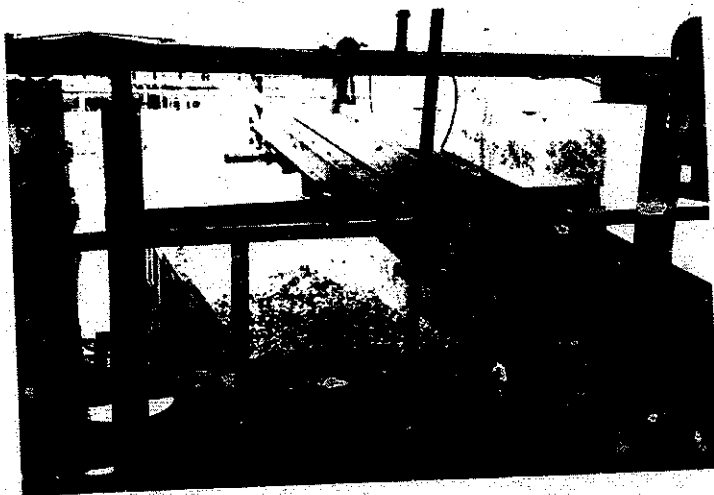
23. Magna/Chardonol/CC&P Facility, 9/20/91, 1:40 to 3:00. View to the north. View of the WTP Sludge Hopper (SWMU #23). SWMU #23 consists of an open topped metal hopper which is used to contain dried sludge produced by the Sludge Dewatering Belt Press (SWMU #9). The sludge is temporarily stored here prior to off-site disposal. This photograph shows the conveyor that links the Belt Press with WTP Sludge Hopper (SWMU #23).

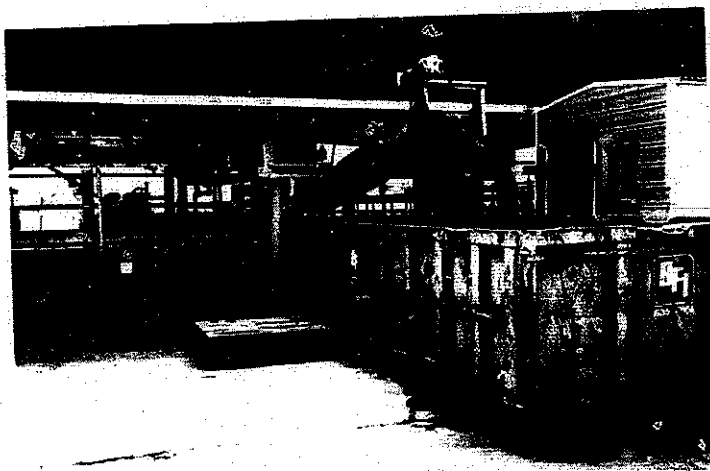
23.1 Magna/Chardonol/CC&P Facility, 9/20/91, 1:40 to 3:00. View to the south. View of the WWTF Sludge Hopper (SWMU #23). This photograph shows the associated Sludge Dewatering Belt Press (SWMU #9). The Treatment Pits (SWMU #8) are also located beneath the open sided structure seen in the background.

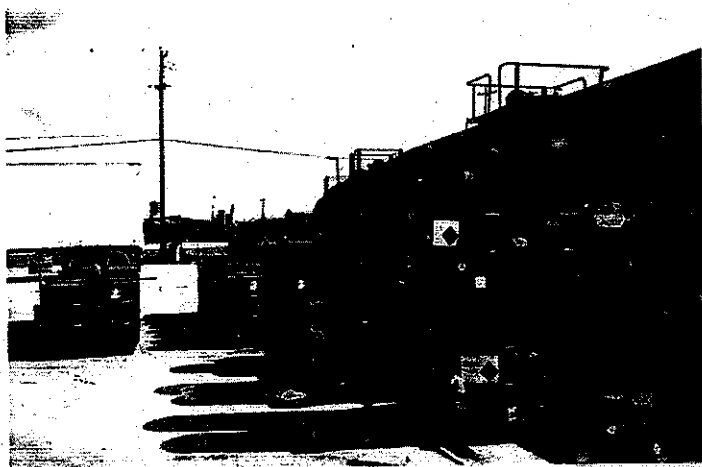
25. Magna/Chardonol/CCSP Facility, 8/29/91, 7:00 to 2:00. View to the north. View of the Drum Staging Area #1 (SWMU #25). This area is utilized to store pallets of 55-gallon drums containing non-hazardous wastes for short periods of time (not more than two weeks) prior to being taken off-site.

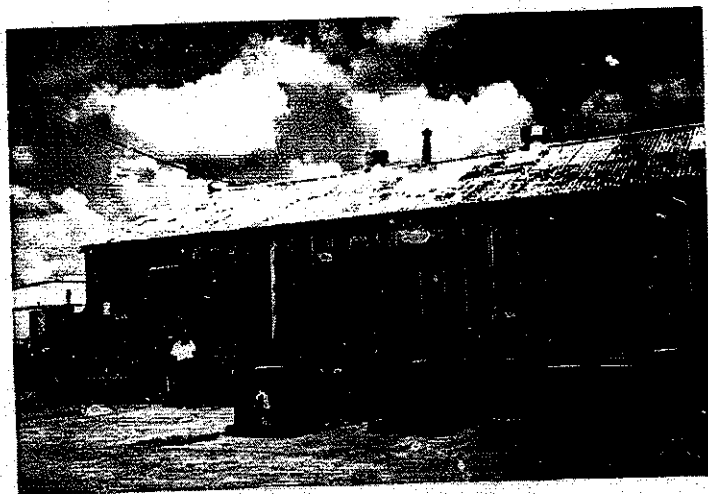
26. Magna/Chardonol/CC&P Facility, 8/29/91, 7:00 to 2:00. View to the south. View of the Drum Storage Area (SWMU #26). This area is used as a temporary storage area for 55-gallon drums containing waste product, lab wastes, and recyclable materials. The building situated behind the drums is the QA/QC Laboratory.

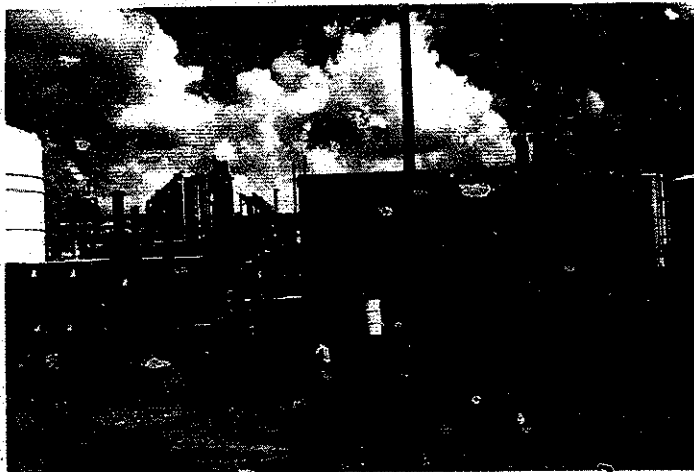
27.1 Magna/Chardonol/CC&P Facility, 8/29/91, 7:00 to 2:00. View to the north. Additional view of the Drum Staging Area #2 (SWMU #27). This unit is used for the temporary storage of non-hazardous sludges and liquids in 55-gallon drums and 400-gallon tote bins. The puddle in the foreground is rain water.

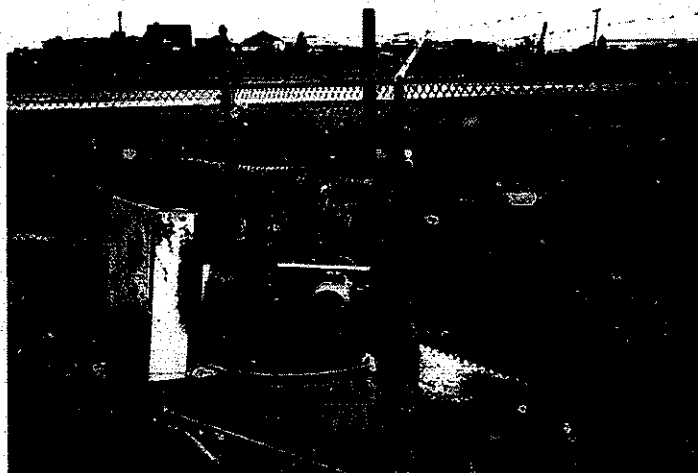
28. Magna/Chardonol/CC&P Facility, 8/29/91, 7:00 to 2:00. View to the north. View of the Sewer Effluent Sump (SWMU #28). This sump discharges pretreated effluent to a sewer connection linked to the City of Houston's POTW. A county drainage ditch is situated adjacent to the sump and lies just outside the plant's perimeter security fence.

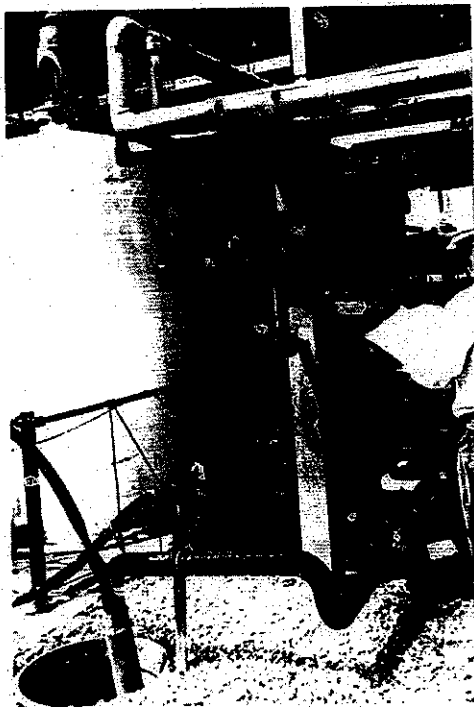
29. Magna/Chardonol/CC&P Facility, 8/29/91, 7:00 to 2:00. View to the west. View of the Sewer Effluent Sump at Treatment Pits (SWMU #29). This unit is part of the flocculation process that is conducted in the Treatment Pits (SWMU #8).

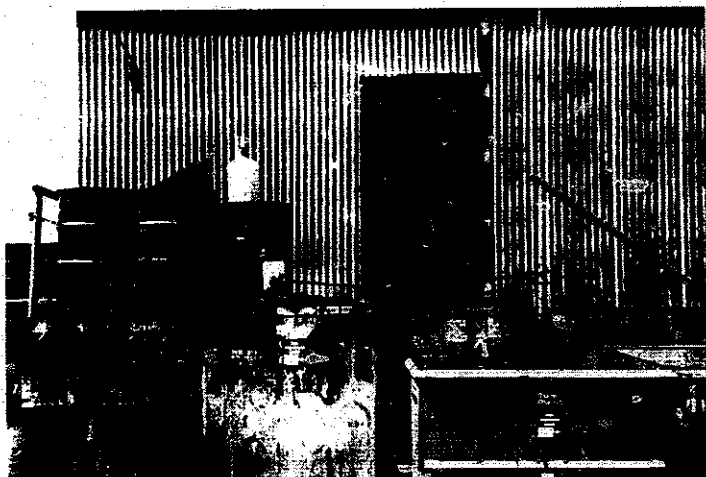
30. Magna/Chardonol/CC&P Facility, 9/20/91, 1:40 to 3:00. View to the north. View of Container Storage Outside Laboratory (SWMU #30). This photograph shows various types of containers used to contain wastes generated in the facility's QA/QC Laboratory. In addition to the tote bin, 55-gallon drums and 5-gallon sized waste containers, a green dumpster designated for non-hazardous trash is also seen.

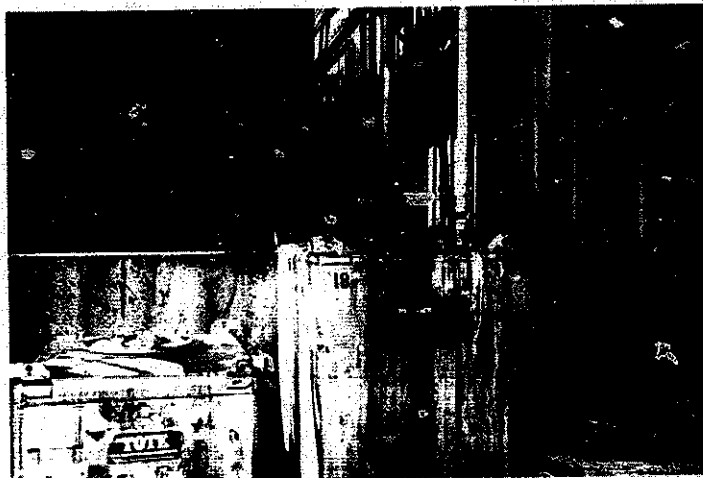
**Unit Description:** This unit is an outdoor concrete floored container storage area located south of the autoclave unit. This above-ground unit is approximately 20 feet long and 20 feet wide. This area is used as a temporary storage area for containers prior to off-site disposal. This unit receives waste from the Tote Bins at Autoclave Units (SWMU #17), Tote Bins at Ester Kettle Unit 1B (SWMU #18), Waste Storage Area at Glass Lined Unit (SWMU #19) and Tote Bins at Finished Compound Blending Unit (SWMU #21). This unit is located on concrete pad.

**History of Releases:** No known releases have occurred from this unit and no visual evidence of releases from the unit was noted during the VSI conducted on August 29, 1991.

**Soil/Groundwater:** The potential for release of hazardous waste or hazardous constituents to soil and groundwater, both past and ongoing, is low due to the unit's location on a concrete pad.

**Surface Water:** The potential for release of hazardous waste or hazardous constituents to surface water, both past and ongoing, is low due to the unit's location on a concrete pad.

**Air:** The potential for release of hazardous waste or hazardous constituents to air, both past and ongoing, is low because the drums are closed.

31. Magna/Chardonol/CC&P Facility, 9/20/91, 1:40 to 3:00. View to the west. View of Container Storage Outside Process Areas (SWMU #31).
